**DIAGNOSTIC OF CONCRETE SAMPLES EXTRACTED FROM
PILE CAPS AFFECTED BY INTERNAL SWELLING REACTIONS**

Master's Thesis presented to the Graduate Program in
Civil Engineering of the Catholic University of
Pernambuco as a partial requirement to obtain the title
of Master in Civil Engineering.

In the last decade, the occurrence of early deterioration of pile cap blocks in residential buildings and concrete bridges in the Metropolitan Region of Recife (MMR) has been reported with relative frequency. This process usually starts with the occurrence of a horizontal crack of large opening in the lateral faces of the element, located approximately 30 centimeters from the upper face of the block, and its installation is usually attributed to the expansions of concrete resulting from the alkali-aggregate reaction.

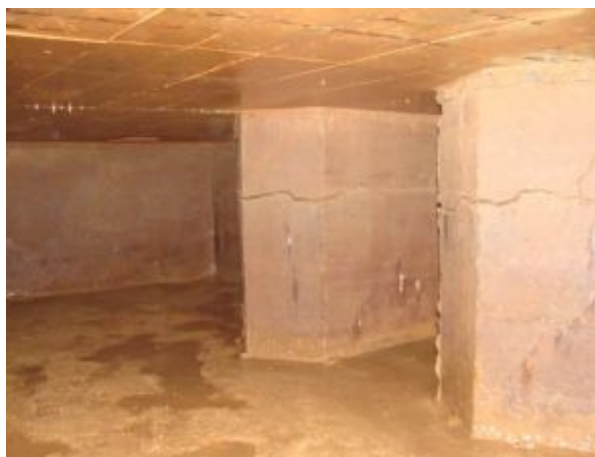
Figure 2. Pile cap foundation with longitudinal cracking [11].

This process is characterized, in some cases, by cracks in the form of a map, and in other cases, cracks with very well defined orientation have been observed, usually horizontal at the top of the blocks on stakes or shoes. The Figures (2, 3, 4 and 5) below illustrate the cracking process described.

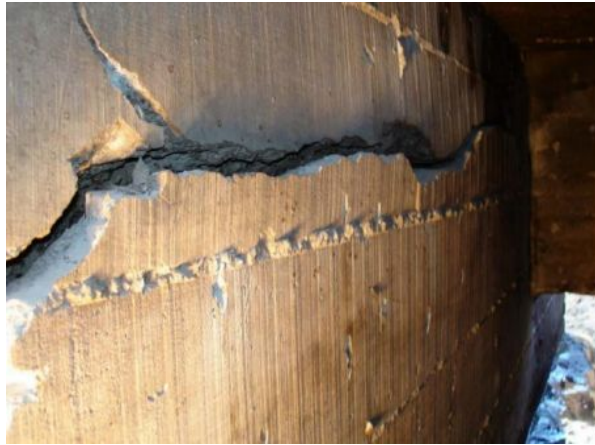
Figure 3. Longitudinal crack and relative horizontal displacement [25].

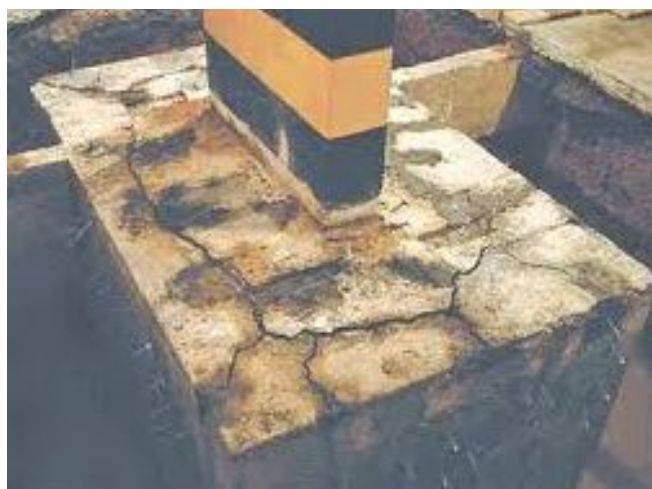
Figure 5. Pile cap block with cracked upper surface, with openings in the order of 25mm [37].

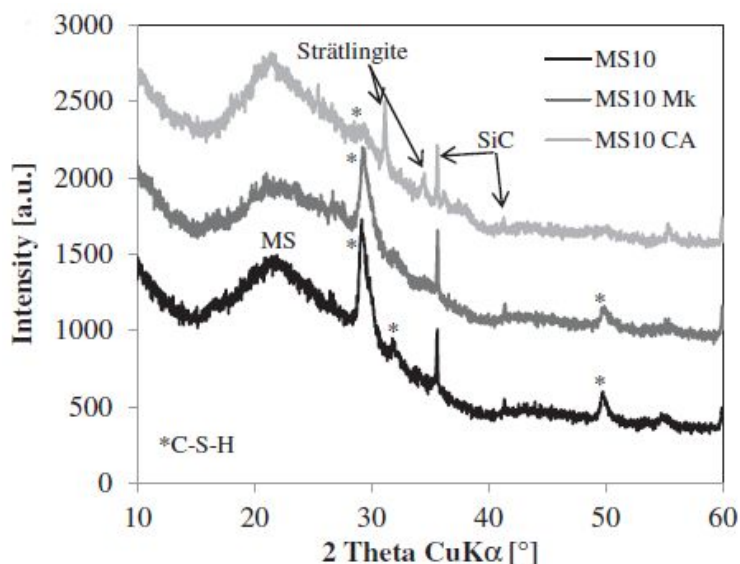
Figure 16. XRD patterns in the samples MS10, MS10 Mk and MS10 CA after 28 days [6].

The XRD standards found by Leemann et al. in [6] indicate for samples MS10 and MS10-Mk that the C-S-H was the main product of the reaction. MS10-CA also presents, but with low crystallization, showing strong signs of strätlingite, illustrated in Figure 16.

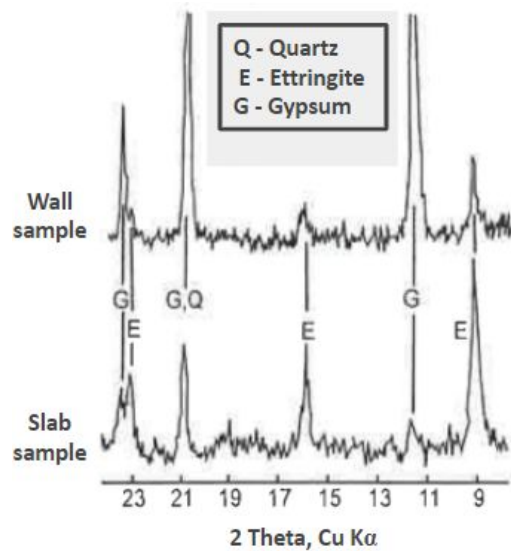
Figure 18. Concrete diffractogram of Fort Peck Dam after sulfate attack [39].

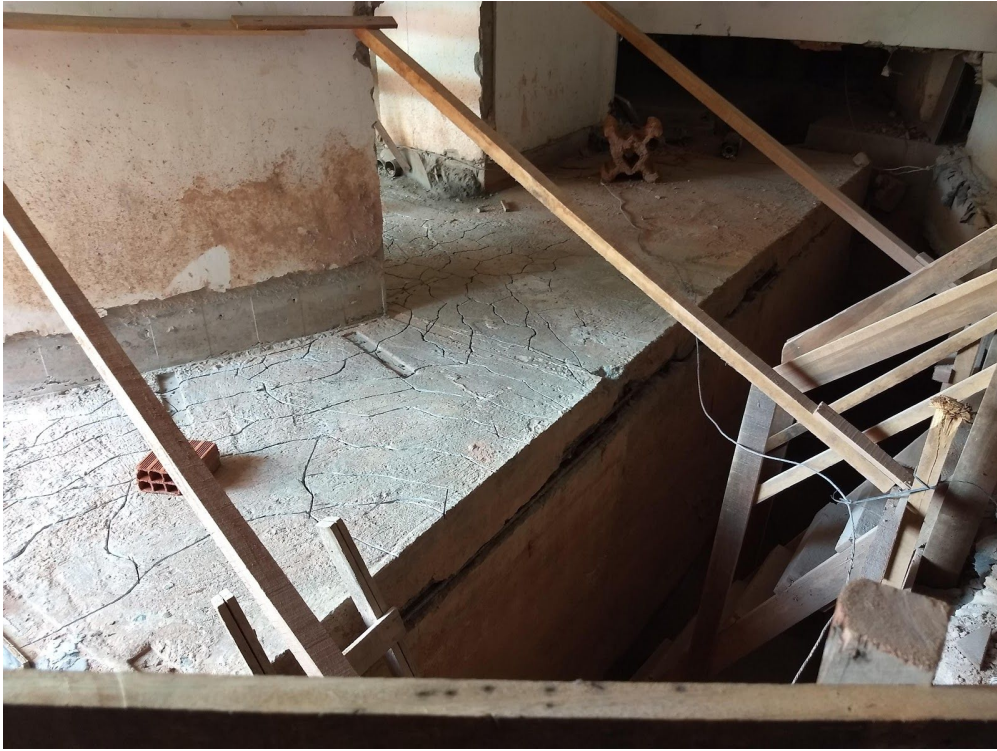
Figure 25. Horizontal and map cracking in pile cap block.

The map cracking in the block was not uniform over the entire block surface (Figures 25 and 26), but at some points it was quite predominant (Figure 29).

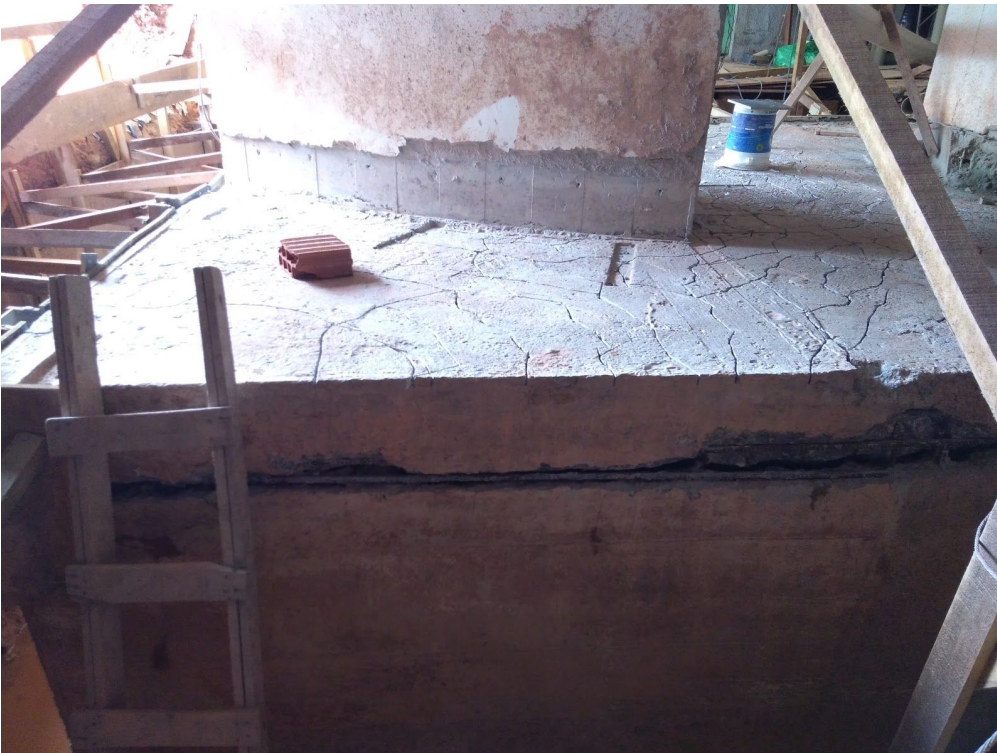
Figure 26. Horizontal and map cracking in pile cap block.

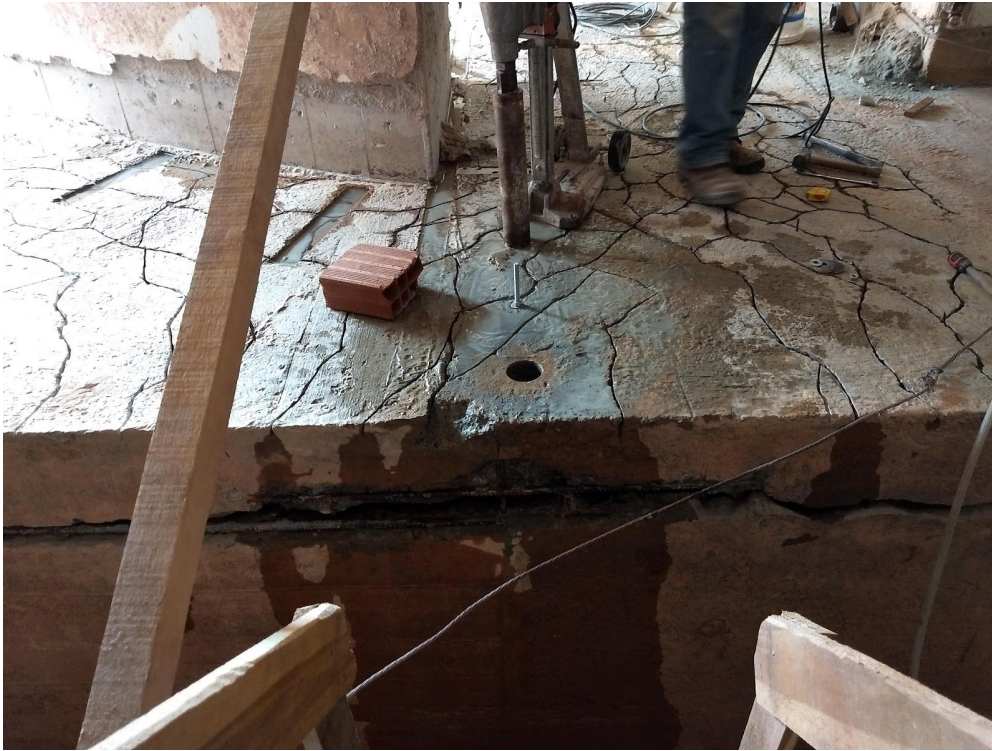
Figure 27. Cracking in pile cap and place where a sample was extracted.

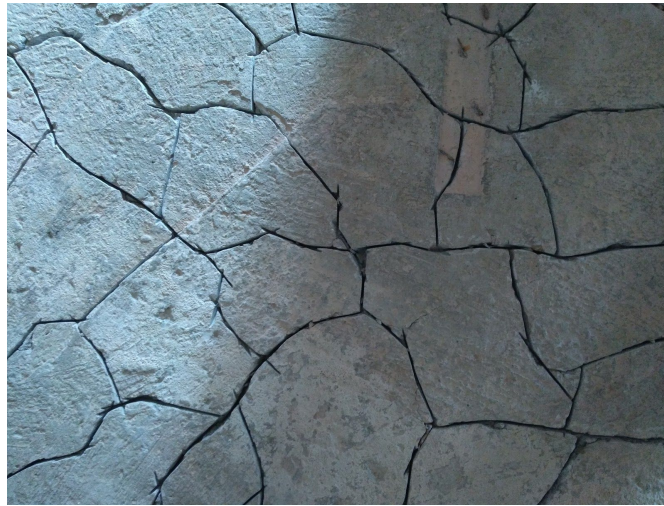
Figure 29. Cracking in map format on the surface of the pile cap foundation S(P1+P8+P32).

were extracted. The cracks in maps were widened for the injection of epoxy in the recovery of damage to the block.

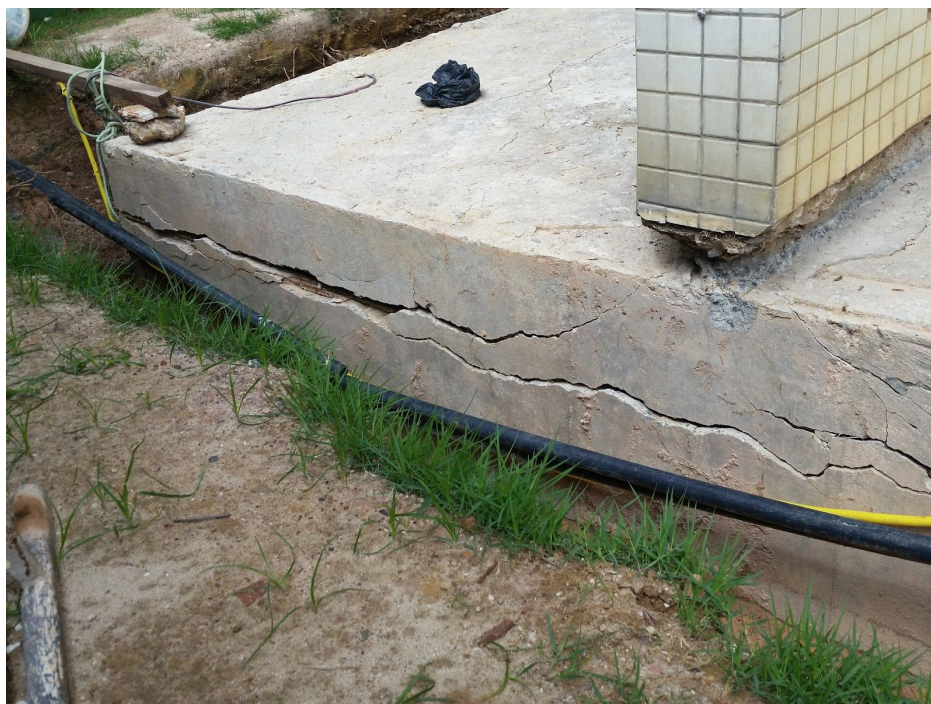
The cracks were larger on the front face of the pile cap block when compared to the cracks in the back part of the structure, as shown in Figure 30.

Figure 30. Longitudinal cracking with a large opening in the pile cap block S(P6+P9) [11].

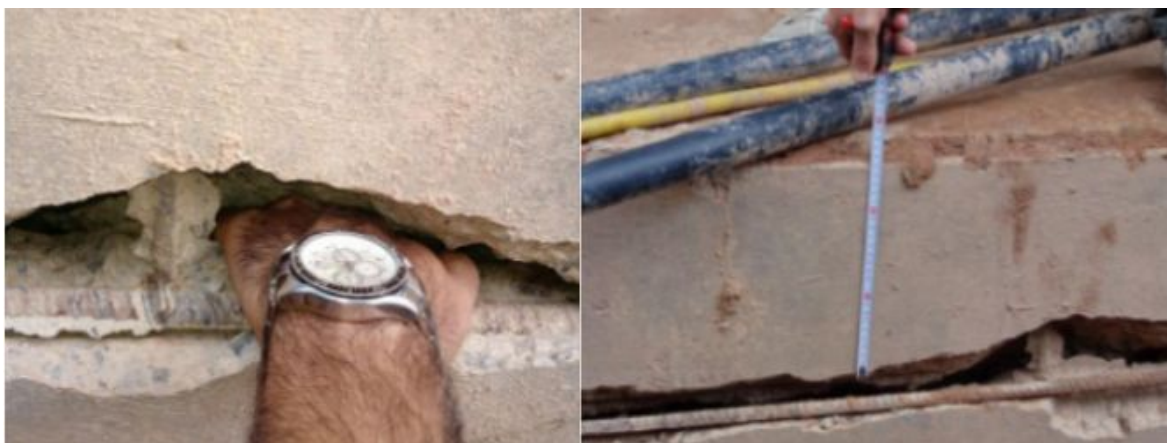
Figure 31. Opening of cracks and depth of the crack [11].

Figures 31 and 32 illustrated the pathological manifestations in the pile cap block (P6+P9) on the face between the E1 and E2 piles [11].

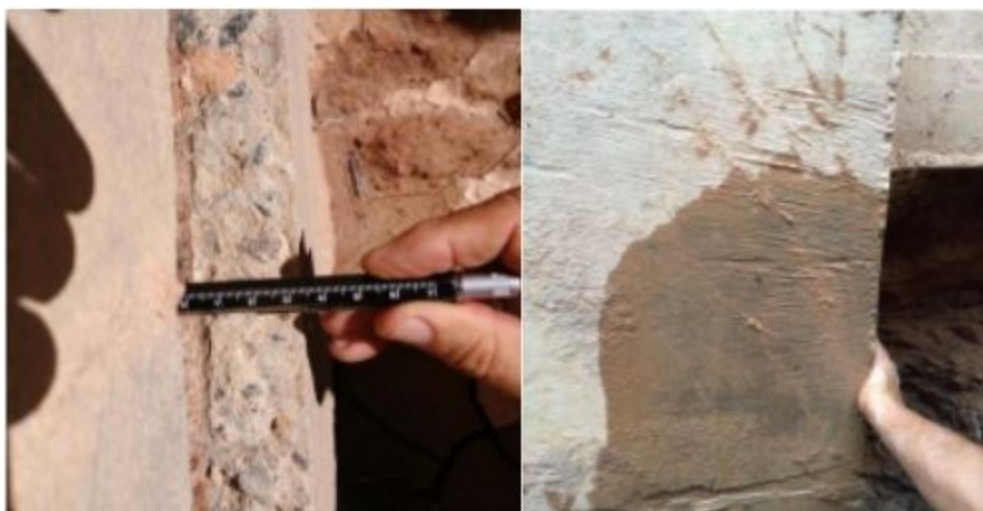
Figure 32. Horizontal displacement and sloping cracks [11].

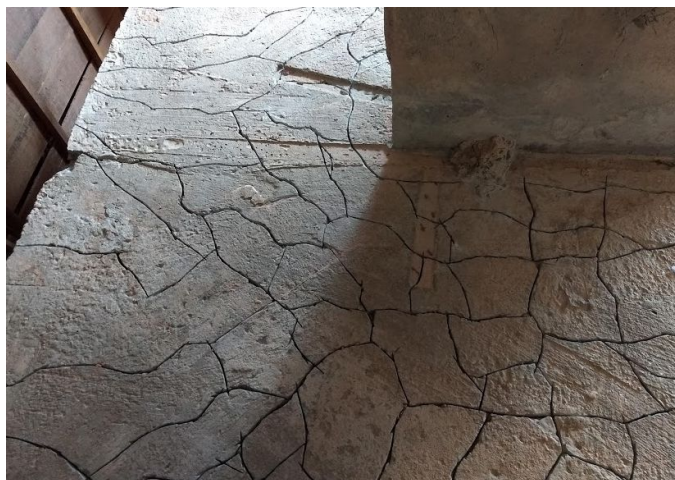
Figure 49. Map cracking on the surface of the pile cap block.

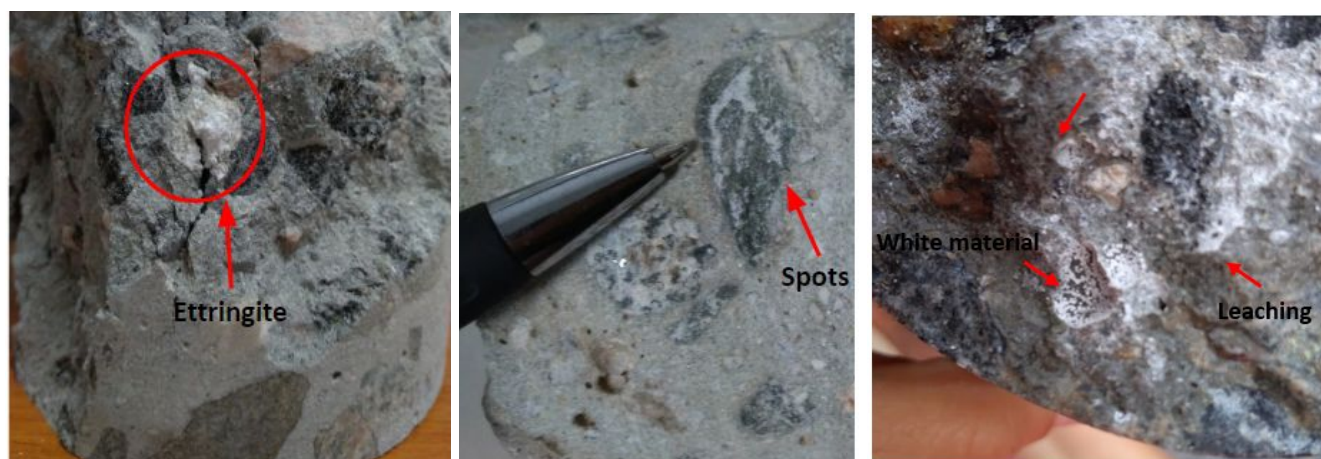
Figure 51. Symptoms of the expansion mechanisms found: a) Pores fullled with ettringite; b) Spots in the aggregate; c) White material in the pores and Leaching.

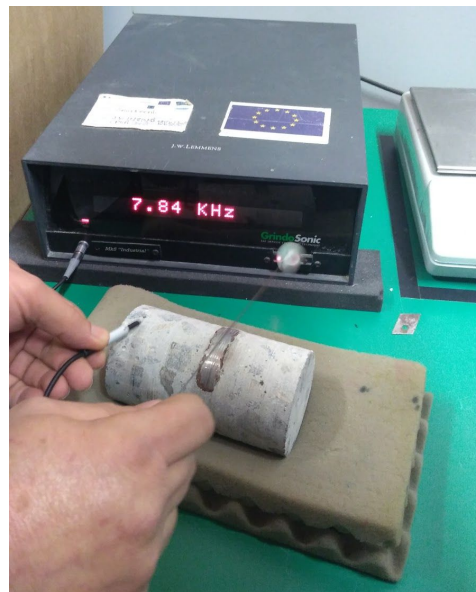
Figure 54. Part of a steel bar in the concrete specimen (AM-1B) during the dynamic modulus test.

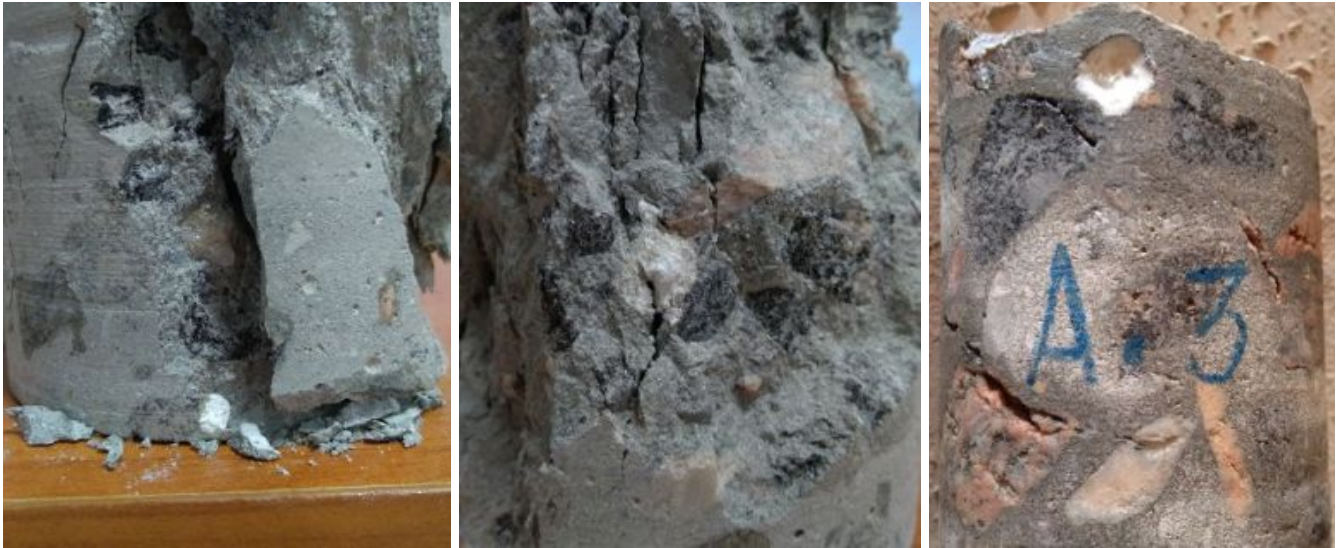
Figure 70. Pores completely filled with ettringite crystals: a) and b) Concrete sample after compressive rupture; c) Concrete sample after extraction.
