CATHOLIC UNIVERSITY OF PERNAMBUCO
POSTGRADUATION PROGRAM IN CIVIL ENGINEERING

**ON THE USE OF EMBEDDED FIBER OPTIC SENSORS FOR
MEASURE STRAINS IN CONCRETE**

Dissertation presented to the Catholic University of Pernambuco and Institut Catholique d'Arts et Metiers in partial fulfillment of the requirements for the degree of Master in Civil Engineering, in the area of Construction Materials.

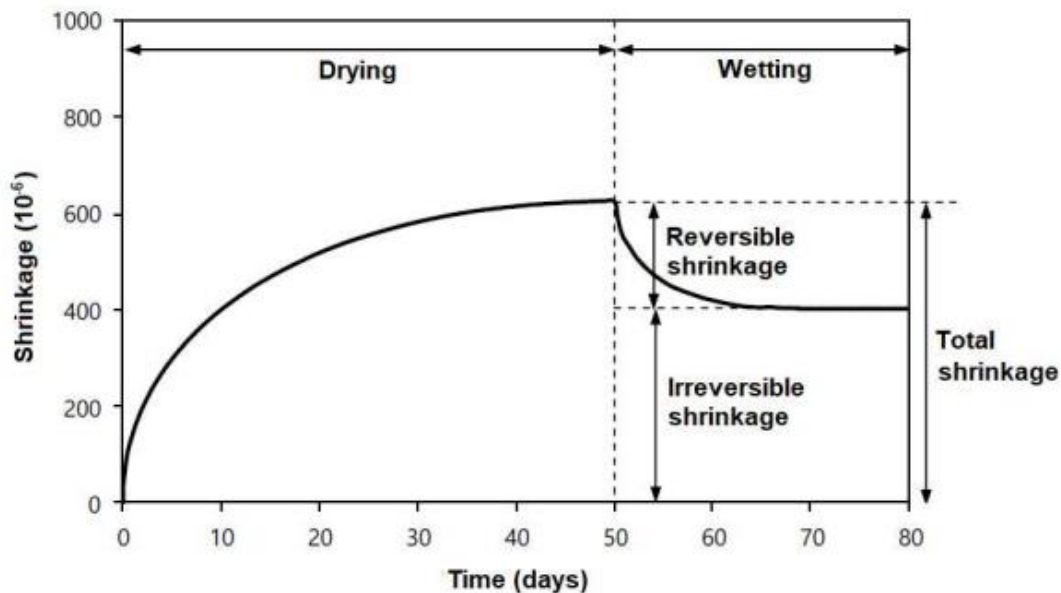
Figure 3: Drying shrinkage classification
(Mehta & Monteiro, 2014)

According Mehta & Monteiro (2014) Drying shrinkage can be classified as reversible or irreversible (Figure 3). Reversible drying shrinkage refers to the diffusion of moisture, the part of the total shrinkage of which can be reproduced by wetting-drying cycles. On the irreversible side, it is no longer possible for the structure to recover from deformation due to shrinkage, even after a long period of storage in water.

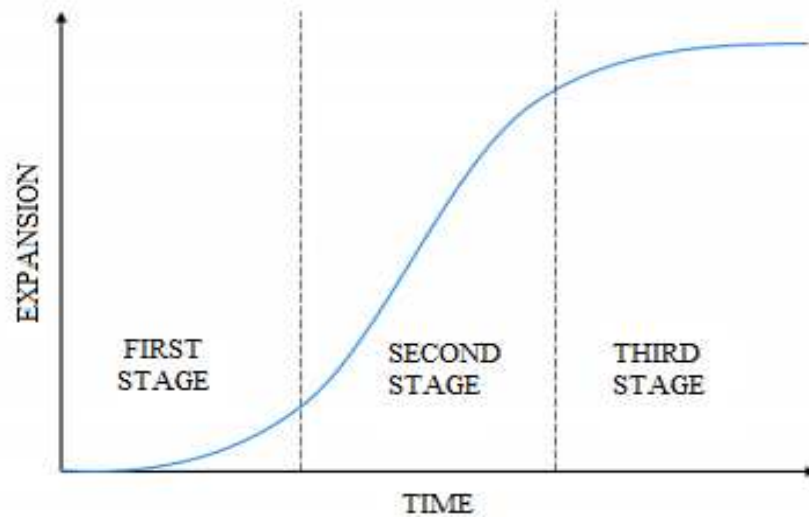
**Figure 9: Stages of alkali-aggregate reaction
(Posterli, 2017) Adapted**

- a) The first moment deals with an initiation phase where the concrete mass becomes saturated by silico-alkaline gel, a by-product of AAR, which absorbs moisture and then expands. In this phase there is no significant expansion, as the pores of the concrete are not fully filled;
- b) The second stage is the development phase. At this stage, the gel has already filled all the pores of the concrete and continues to absorb water, causing the expansion of the concrete to begin to occur;
- c) Finally, the third stage is when the reactive material runs out, so that the gel formation stops and the expansion process stops.

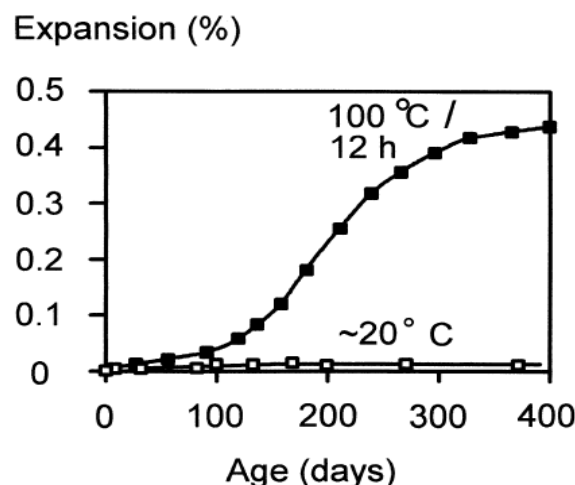
Figure 15: expansion curve of a mortar cured at 20° C and 100° C.
(Taylor *et al.*, 2001)

In relation to DEF the Figure 15 shows the difference in the behavior of a mortar cured at a high temperature and a mortar cured at room temperature. It is possible to observe that the expansion levels are very different between mortars.

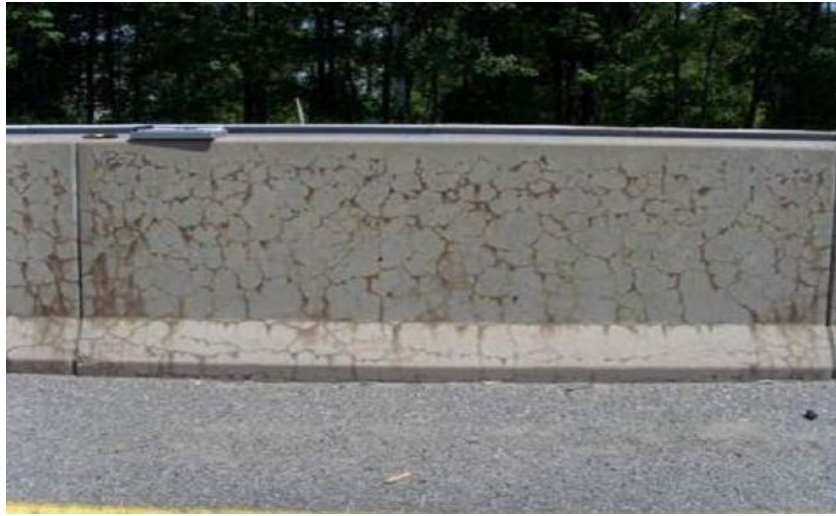
Figure 16: ASR damage on barrier walls.
(Thomas et al, 2013)

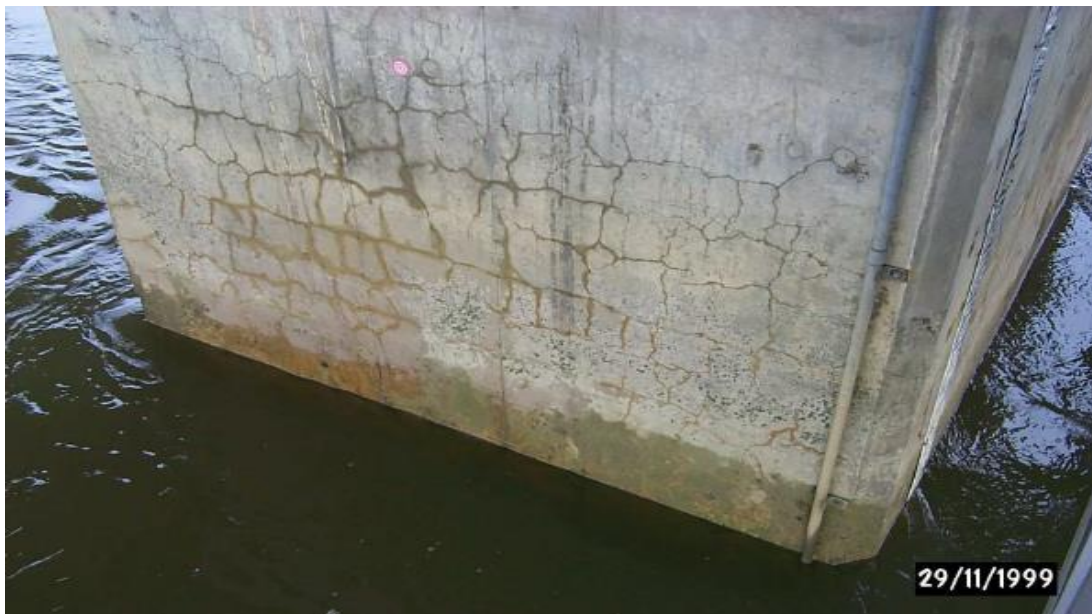
Figure 17: Pier 6 of the Bellevue Bridge with map cracking in the tidal zone (DEF).
(Godart and Divet, 2013)

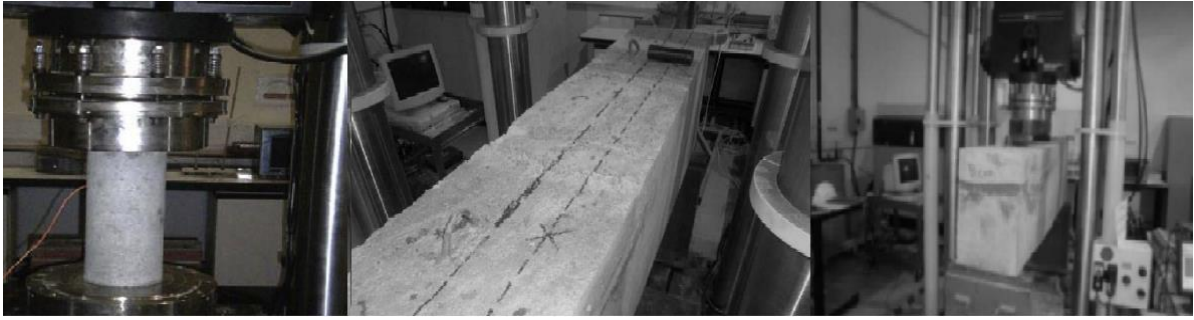
Figure 28: cylindrical sample and beam during the tests
(Yehia *et al.*, 2014)

To identify temperature variations during the hydration of the concrete, thermocouples were incorporated in the middle and on the surface of the beams, the embedded sensors could detect temperatures between 40°C and 100°C. All sensors were connected to the data acquisition system right after molding to record deformations due to the heat of hydration and also the shrinkage of concrete. The same procedure was used for both beams and cylindrical specimens. Monitoring was done continuously for 7 days. In the Figure 28, it is possible to observe the performance of tests with cylindrical samples and concrete beams.

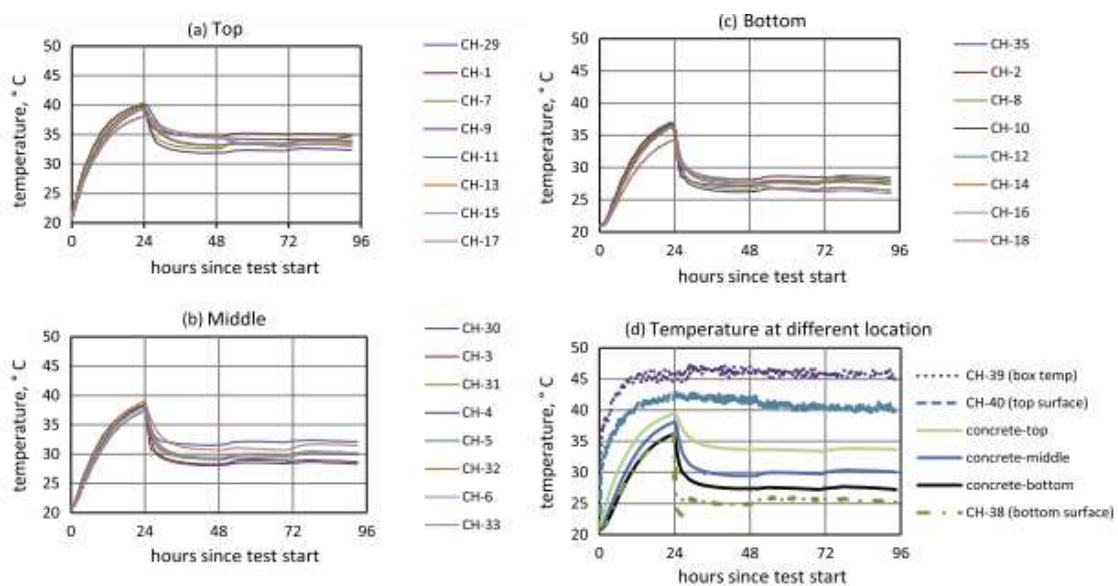
Figure 33: Temperature gradient through beam depth
(Yu Ge *et al.*, 2014)

The Figures 33 and 34 show, respectively, the results of temperature measurements and deformation measurements due to thermal action before and after temperature compensation.

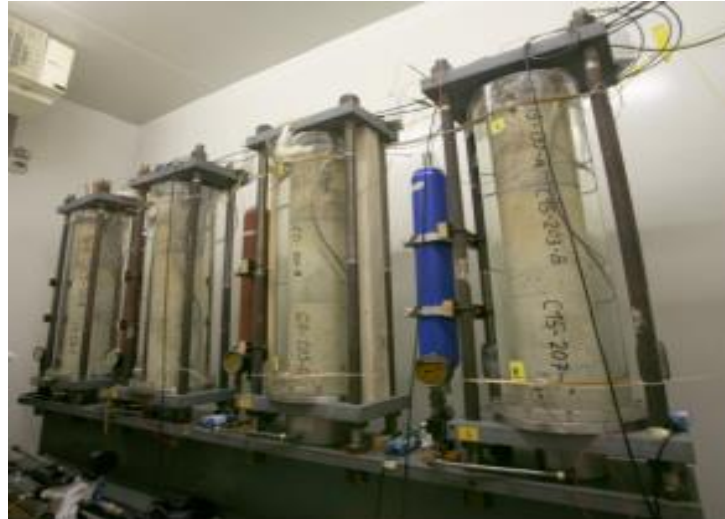
**Figure 35: Samples in the loading frame
(Dunant & Scrivener, 2012)**

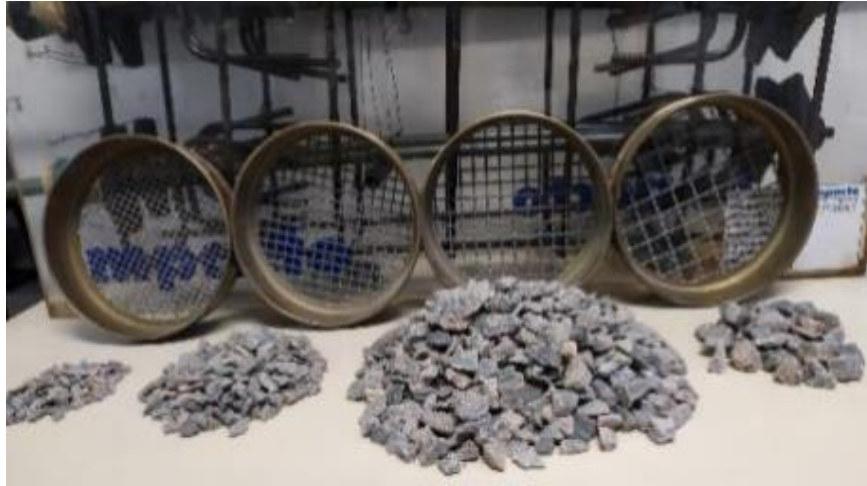
Figure 39: Granulometry test of coarse aggregates
(Author, 2020)

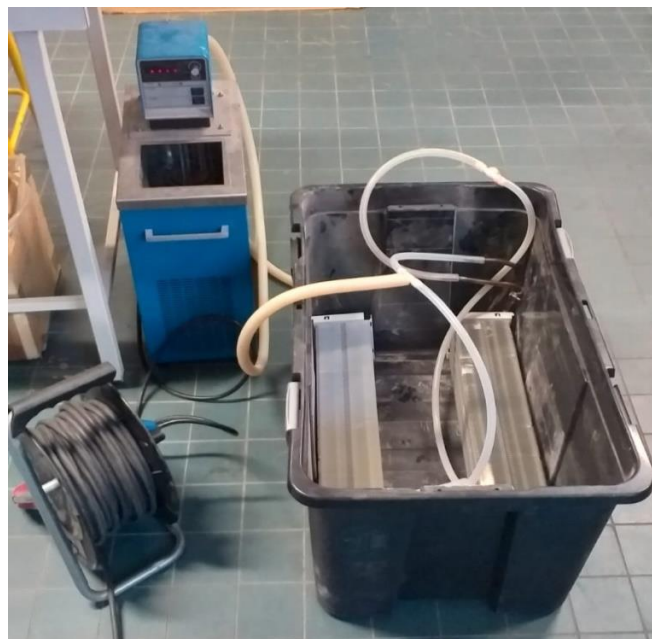
Figure 42: Tank with the heating system (Author, 2020)

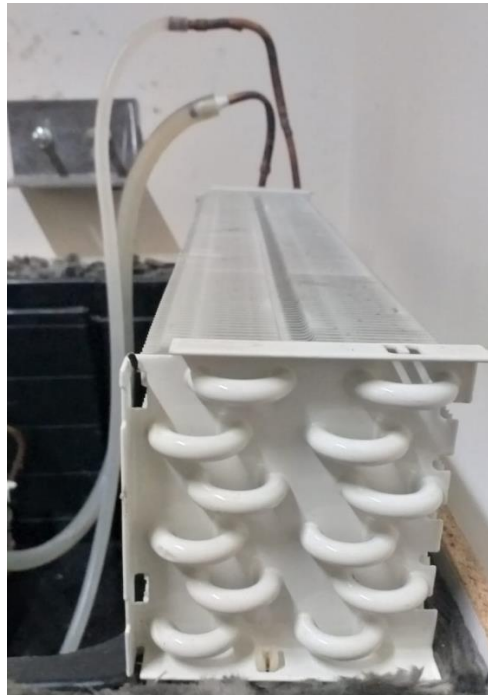
**Figure 43: Reactor used in the heating system
(Author, 2020)**

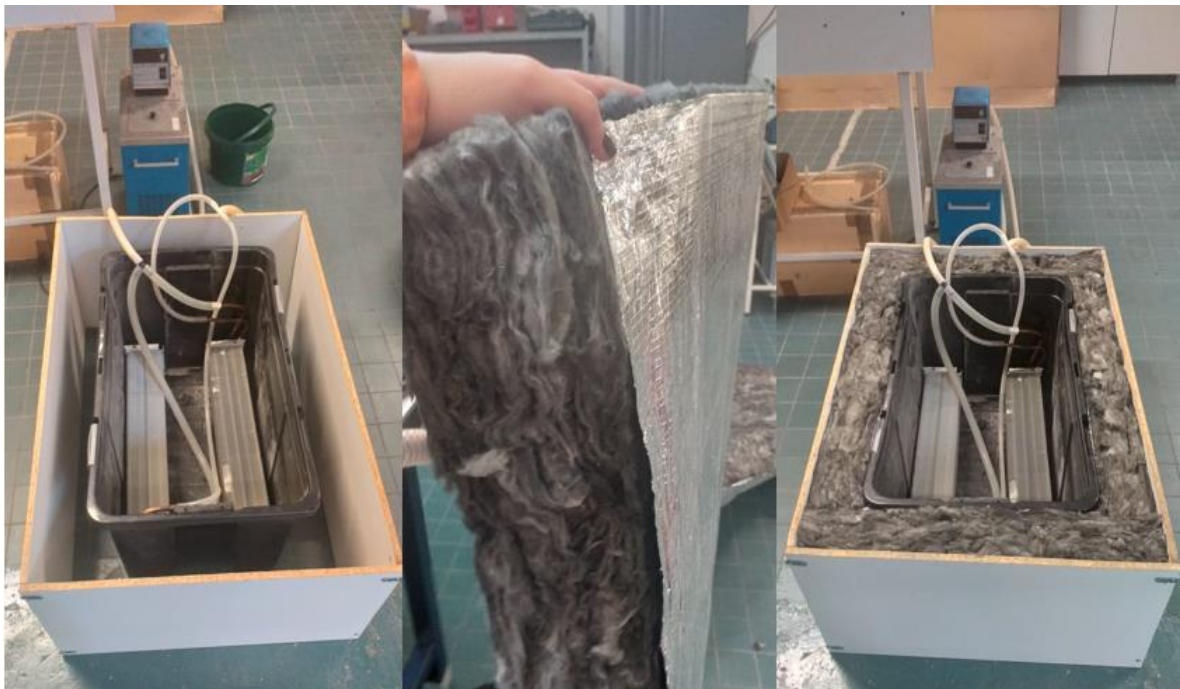
**Figure 44: Thermal insulation of the tank
(Author, 2020)**

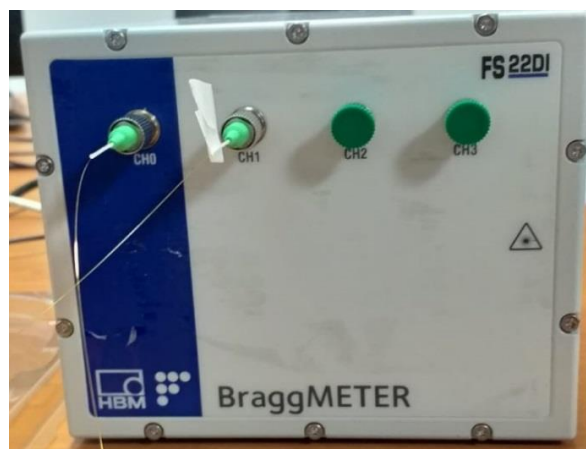
Figure 46: HBM FS22 DI Industrial BraggMETER optical interrogator
(Author, 2020)

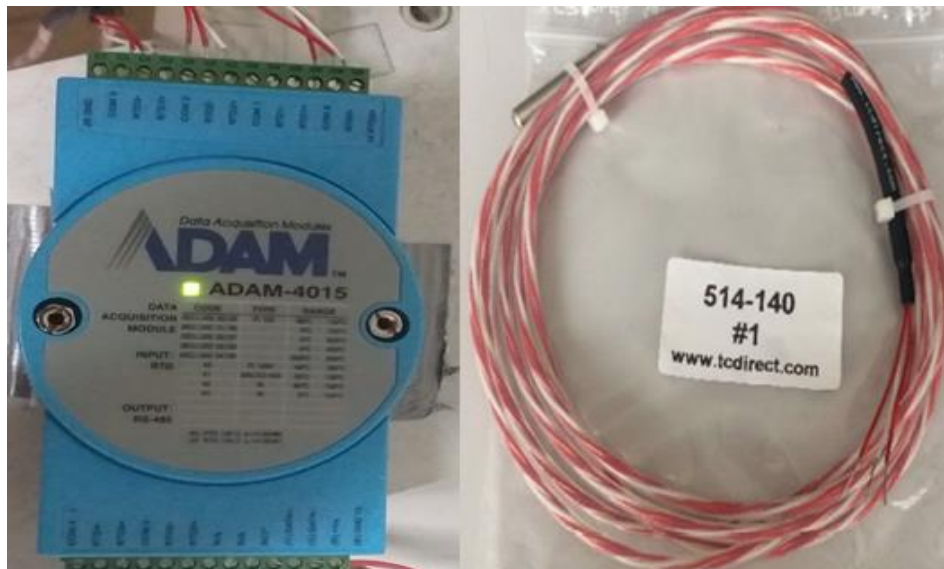
Figure 47: Temperature measurement system and temperature sensor (Author, 2020)

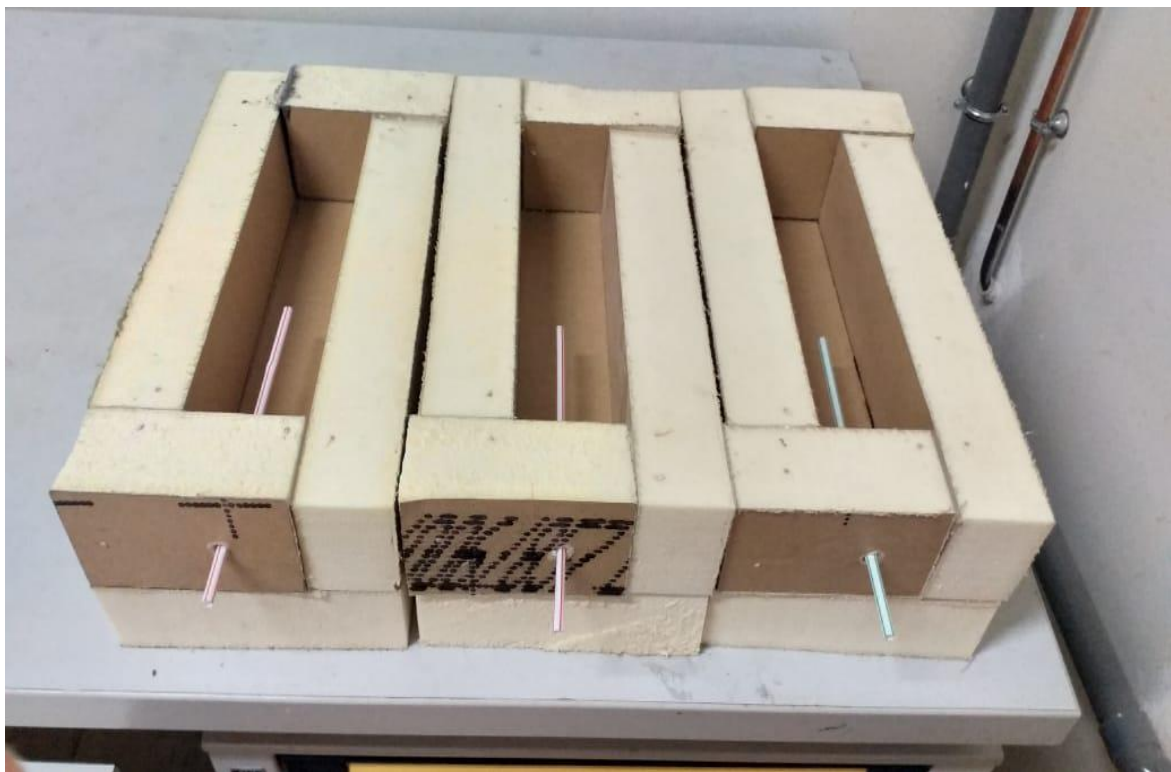
**Figure 49: Molds with hole for sensor insertion
(Author, 2020)**

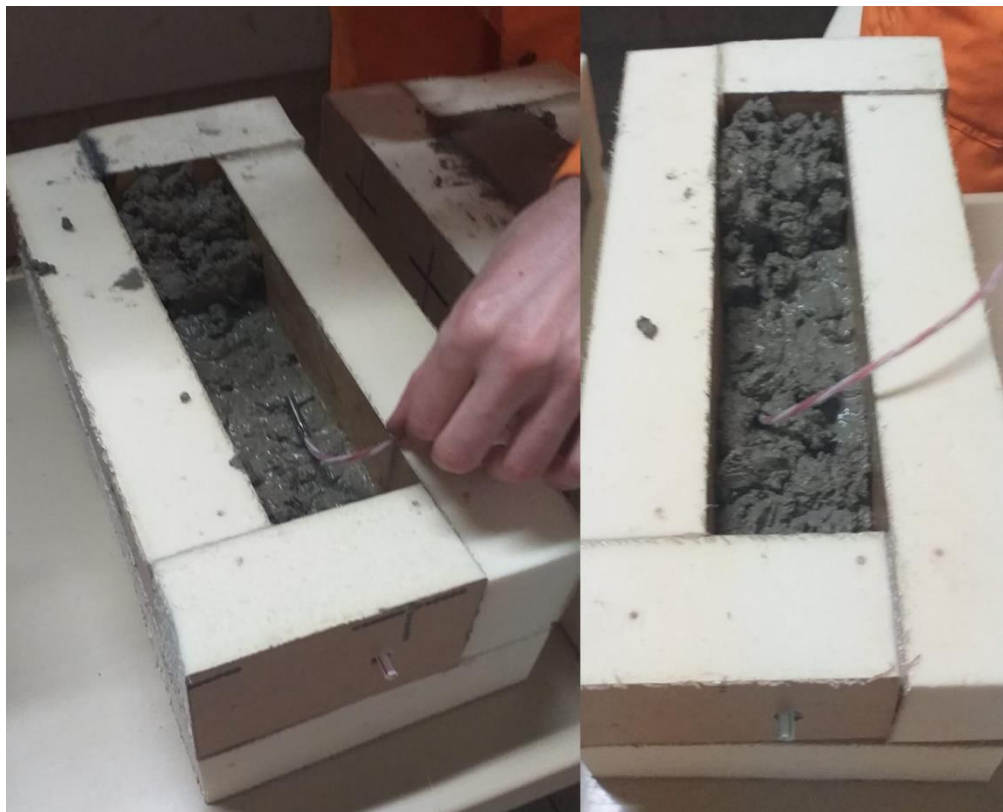
Figure 51: Temperature sensor insertion
(Author, 2020)

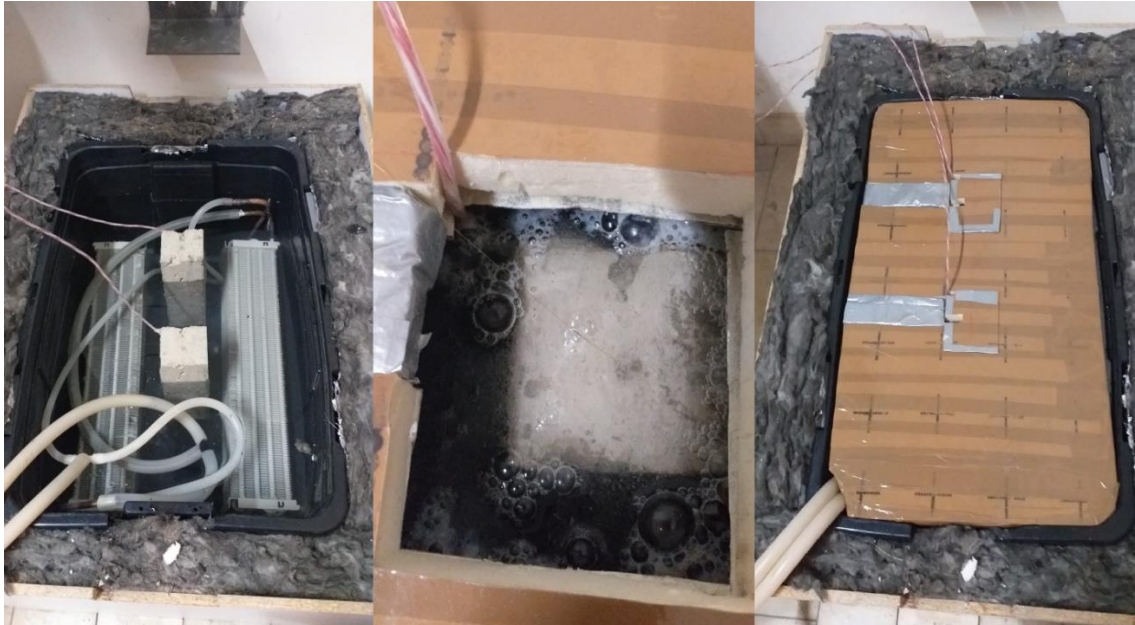
Figure 54: Concrete prisms inside the tank
(Author, 2020)

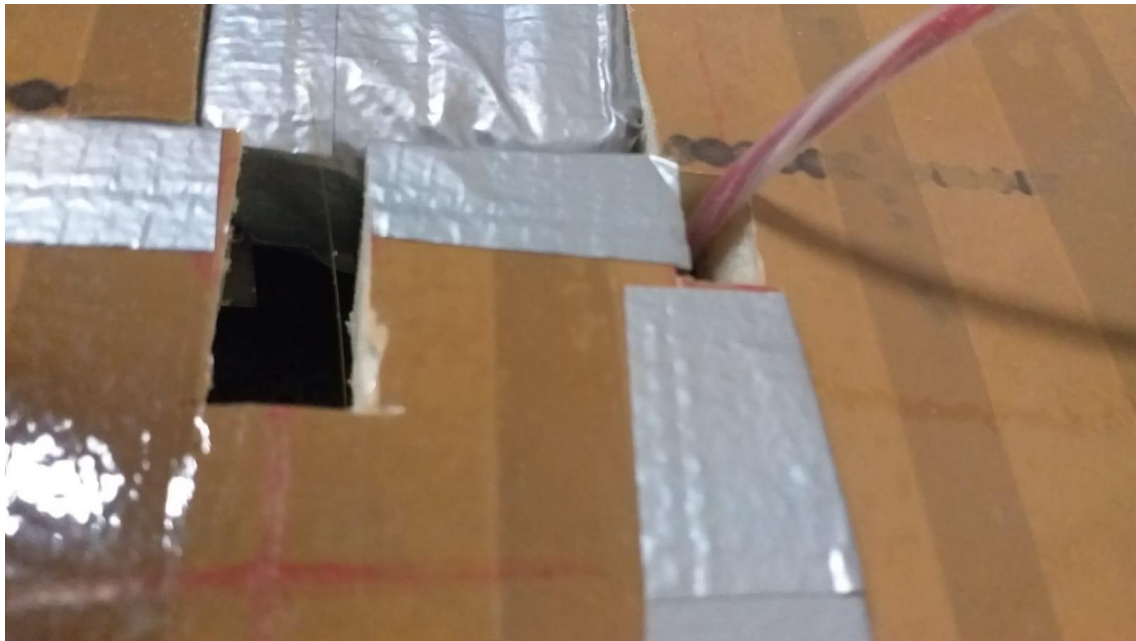
Figure 55: Openings to Allow the Passage of the Sensors
(Author, 2020)

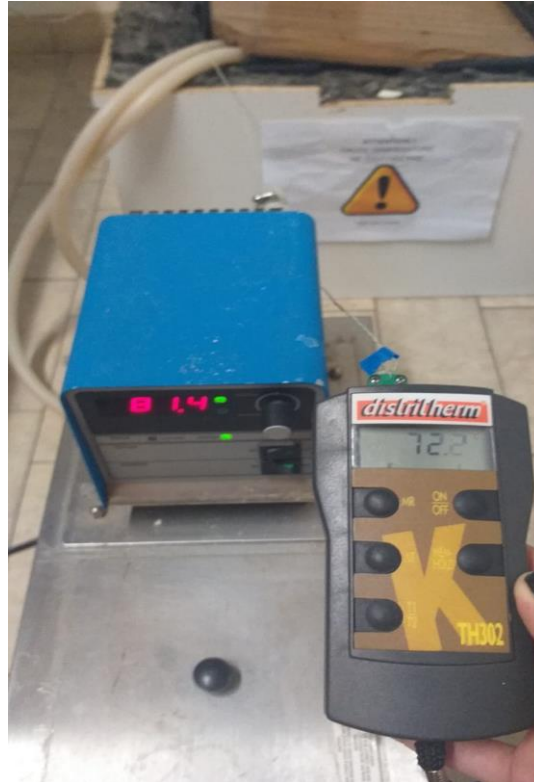
Figure 56: Temperature variation between the machine and the NaOH solution
(Author, 2020)

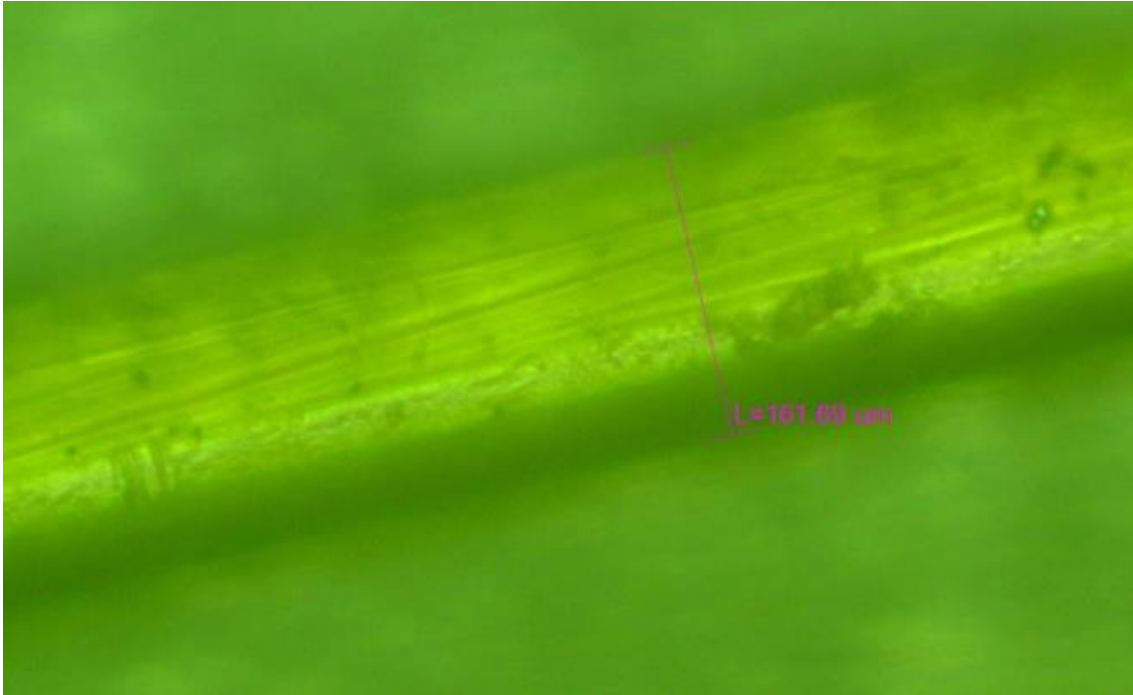
**Figure 68: Optical fiber without contact with the NaOH solution
(Author, 2020)**
